Appendix B: Photographs of Existing Conditions

The following photographs illustrate typical exterior and interior conditions at the Bok Kai Temple. These photographs were taken by Architectural Resources Group over several site visits during Spring 2002.

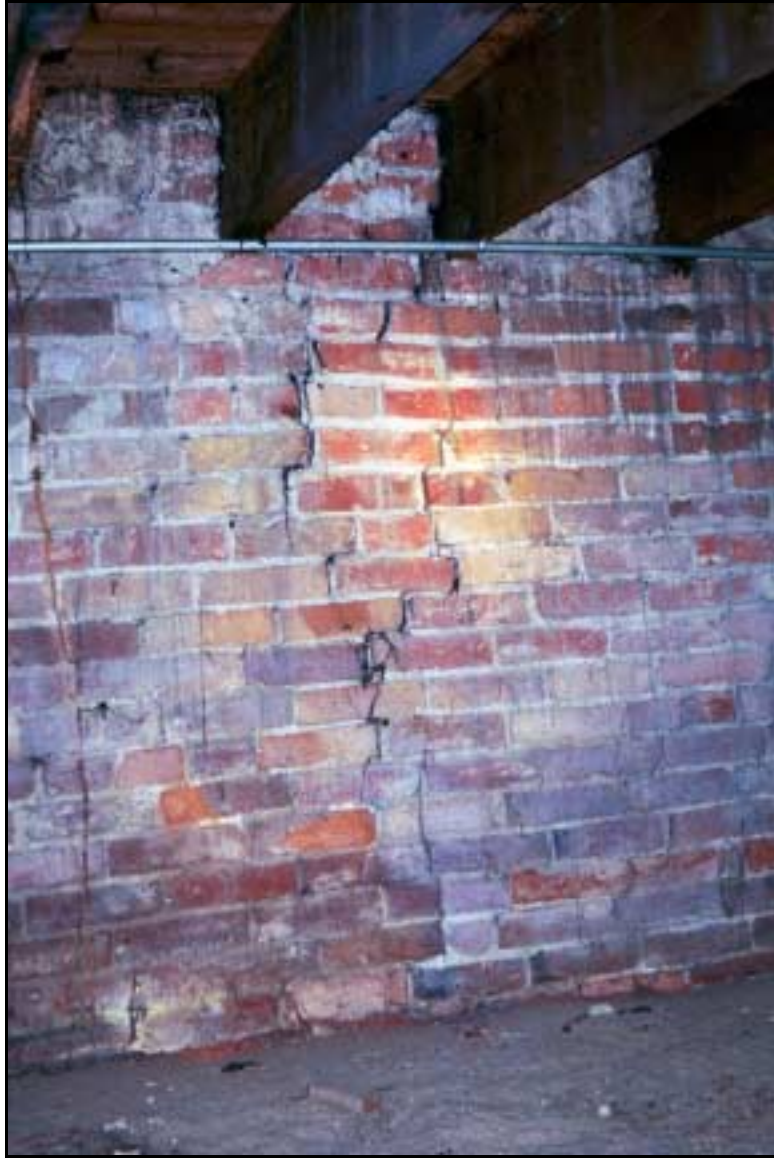
Figure 7. The photograph shows a crack in the east wall of the brick foundation below the altar hall.

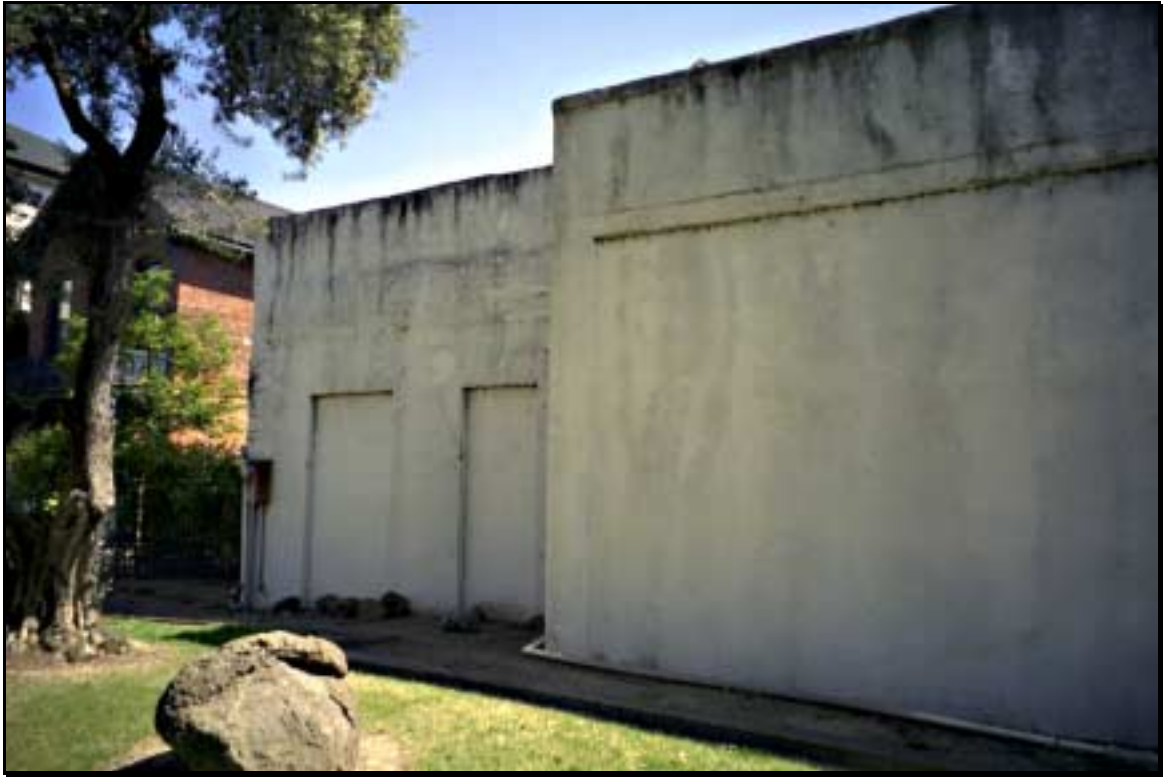
Figure 8. The exterior walls of the west elevation and most of the south and north elevations are stuccoed brick walls. There is some cracking in the stucco and soiling of the painted surfaces.

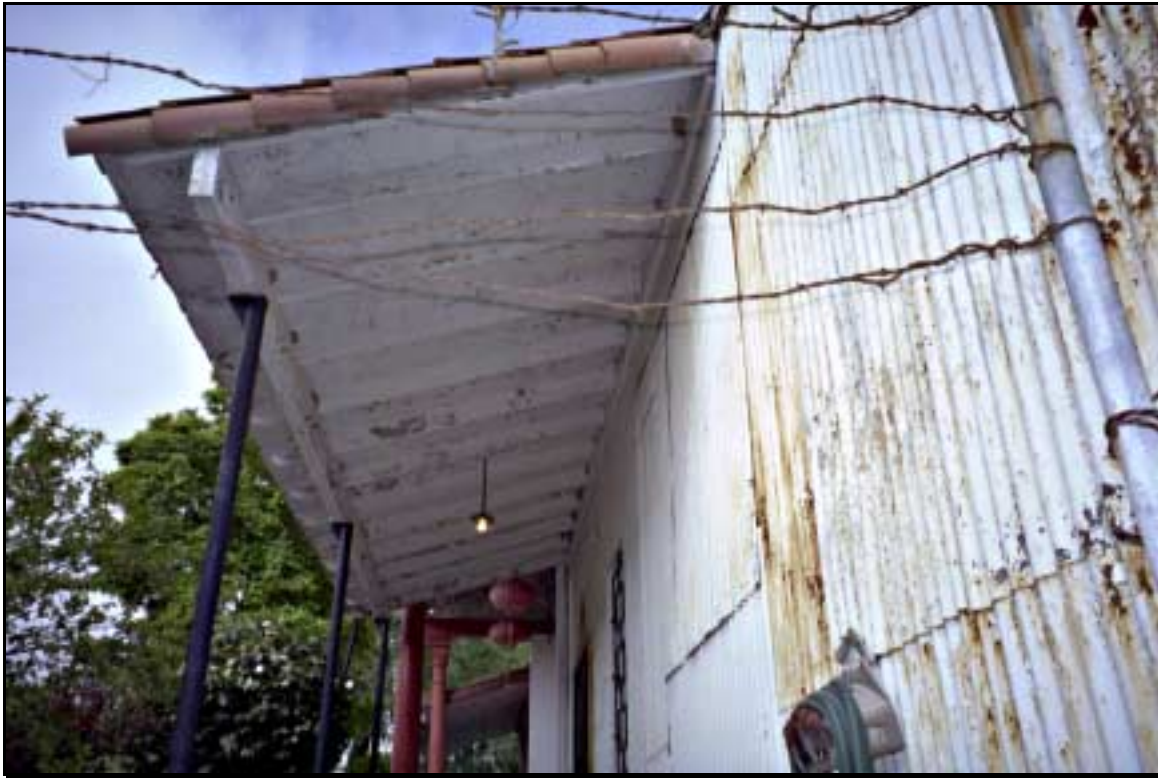
Figure 9. The exterior walls at the eastern portion of the caretaker's wing have corrugated metal siding. The metal is corroding in some locations, and the paint coatings peeling from the galvanized surfaces.

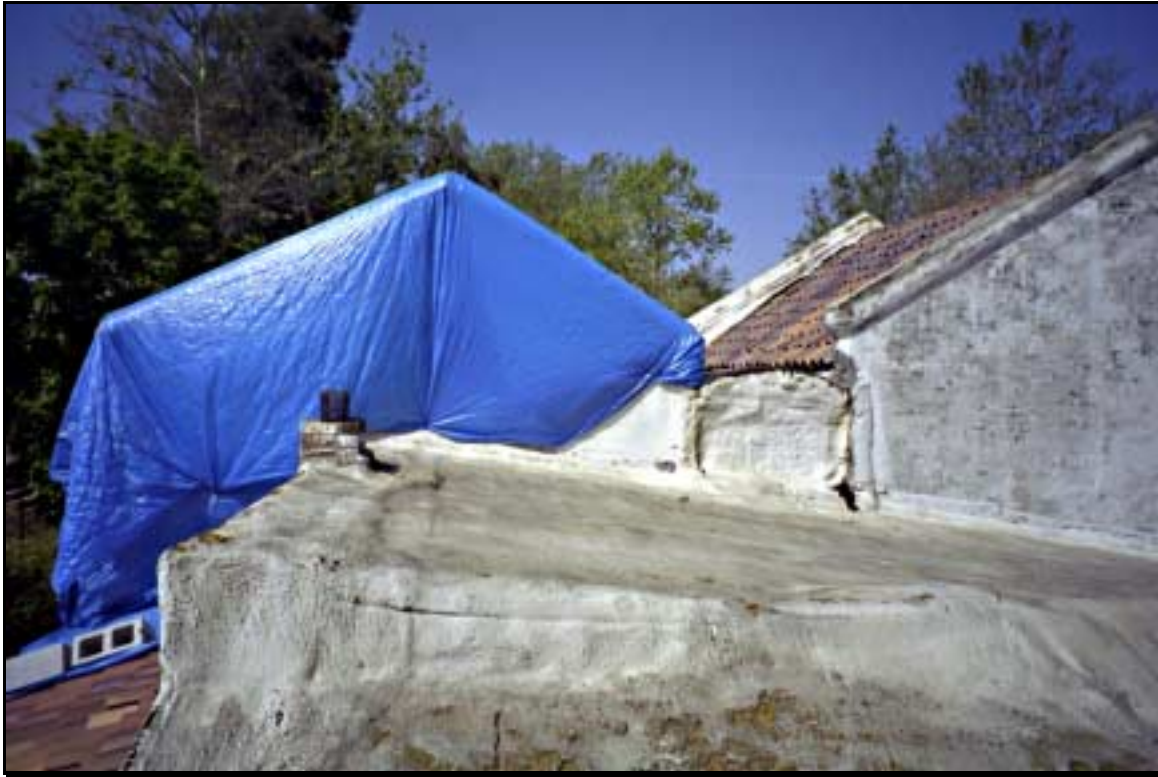
Figure 10. The roof of the caretaker's wing, the barrel vault over the altar hall, and the council chamber is a sprayed-on foam material. This roofing is failing in many locations. The gable and visor roofs have clay tiles, which are in better condition.

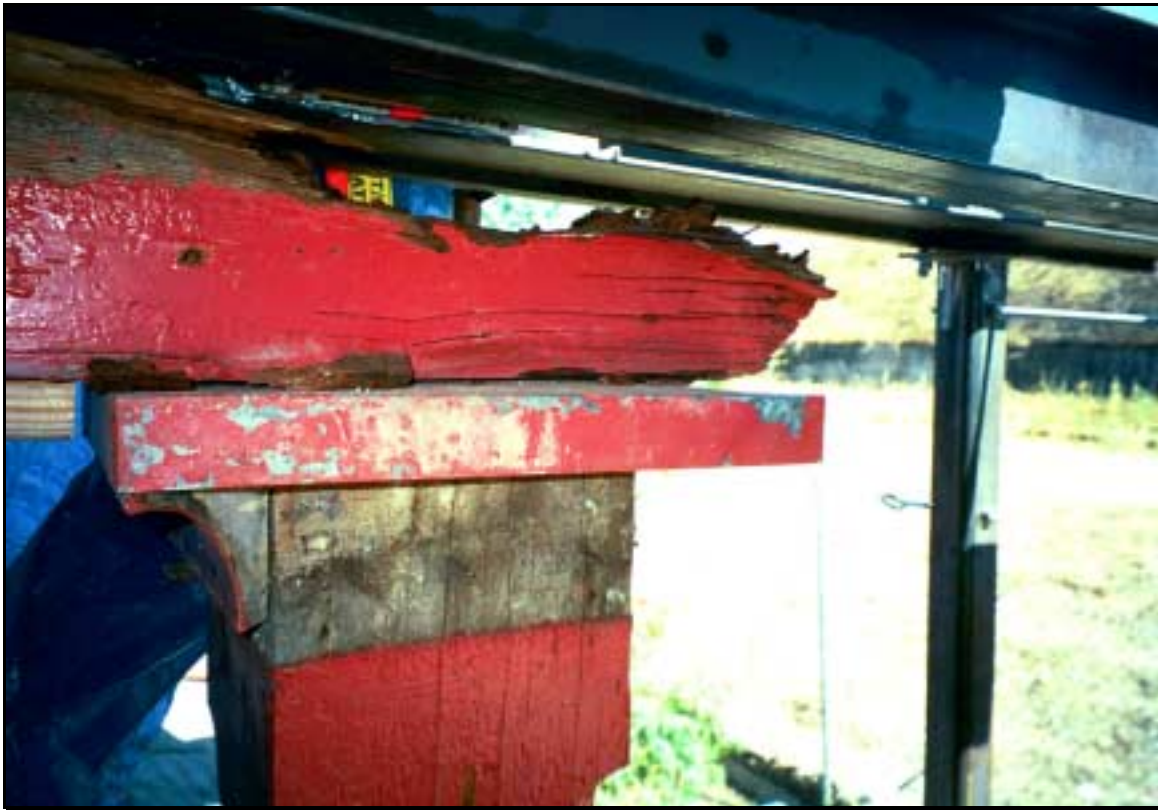
Figure 12. The end of the wood beam at the east end of the porch is severely decayed, resulting in movement of the brick wing wall and extensive damage to the mural painting. The end of the beam rests on a wood column.

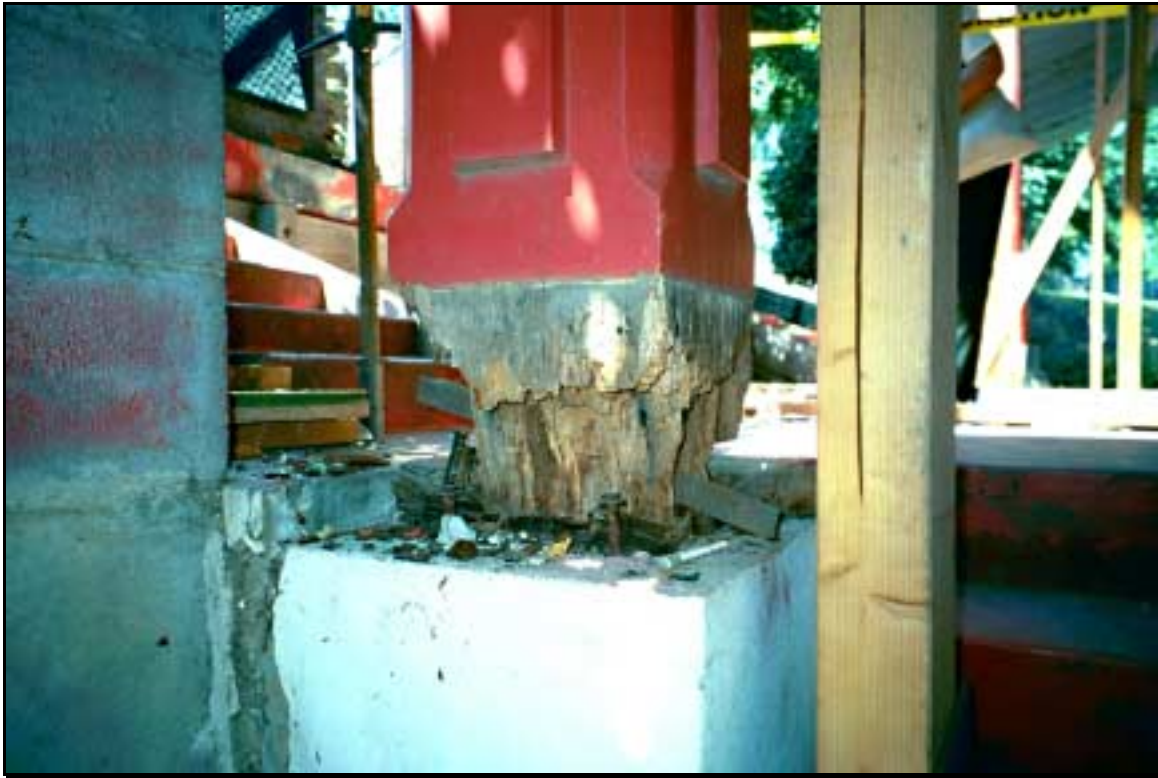
Figure 13. The base of the wood column at the east end of the porch is also severely decayed. Evidence of previous repairs to the wood column include the insertion of new wood pieces and pinning with metal anchors.

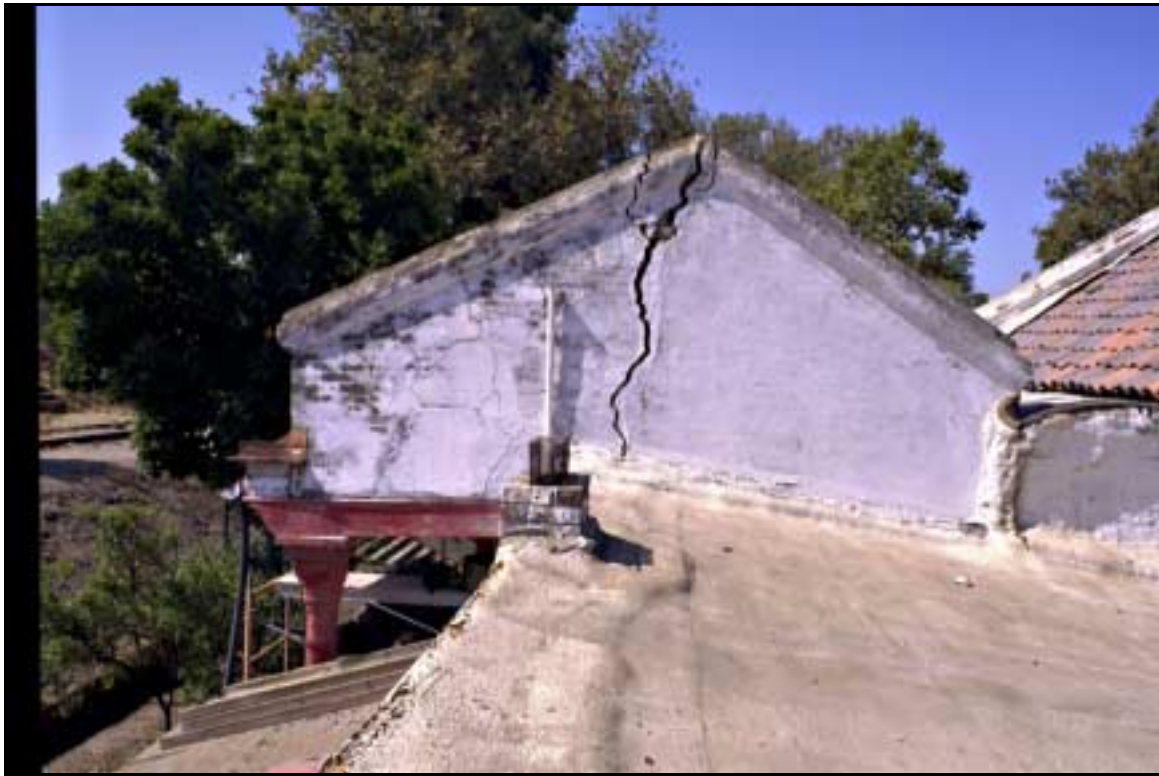
Figure 14. The wing wall of the porch is the north, or left, half of the smaller gable over the altar hall. Deterioration of the wood beam and column at the porch has caused extensive cracking through the wing wall.

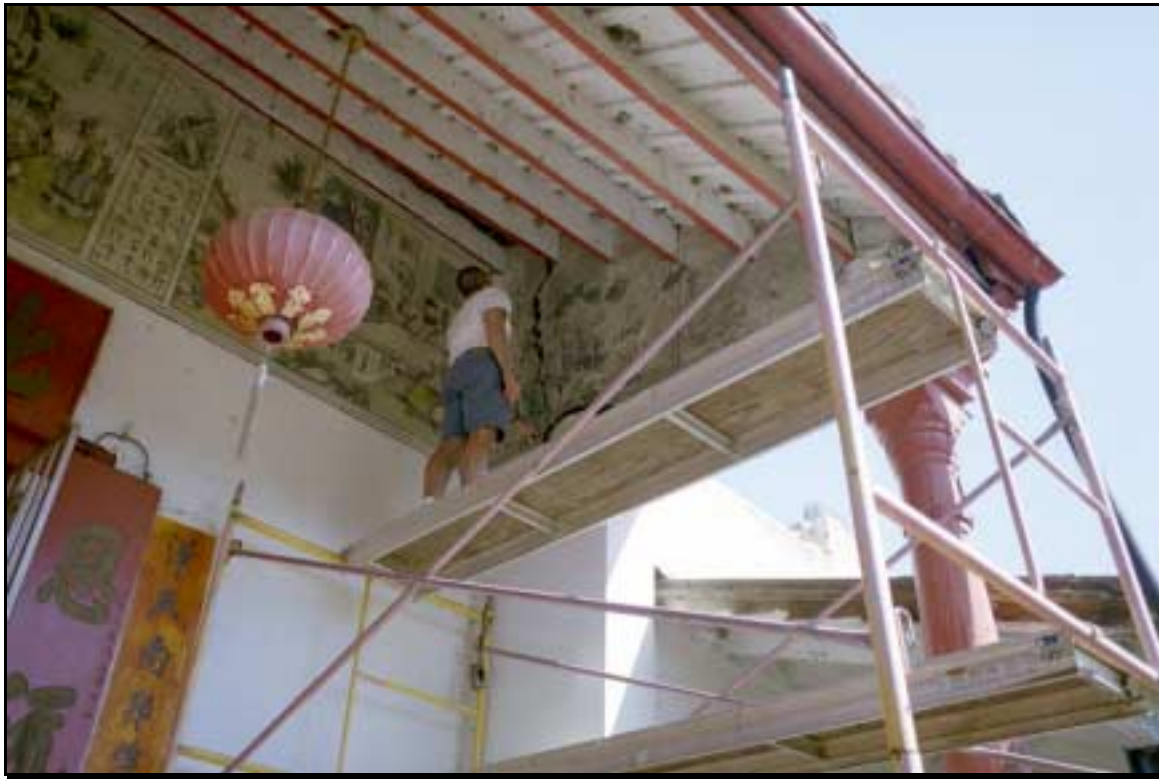
Figure 16. The extensive cracking visible on the outboard side of the east porch wing wall extends through the painted surface of the mural.

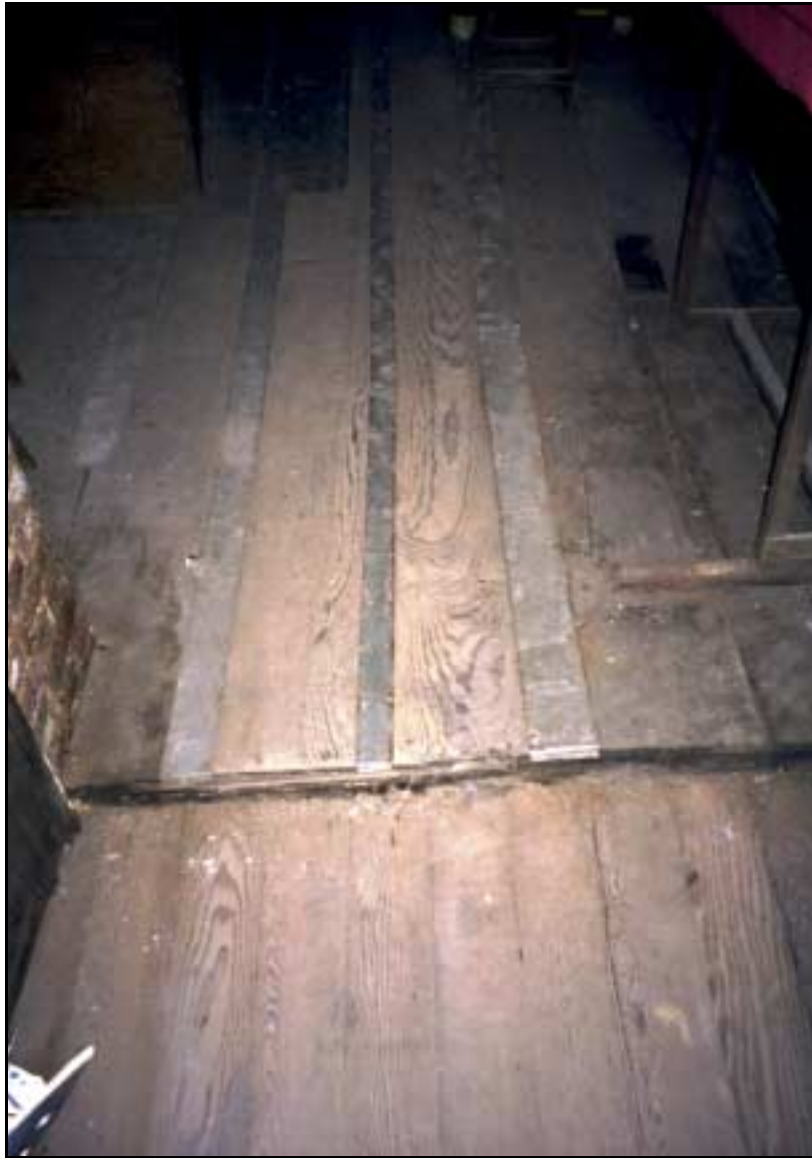
Figure 17. The floors in the caretaker's wing are wood plank floors. Some of the floors planks have been replaced or repaired using sheet metal.

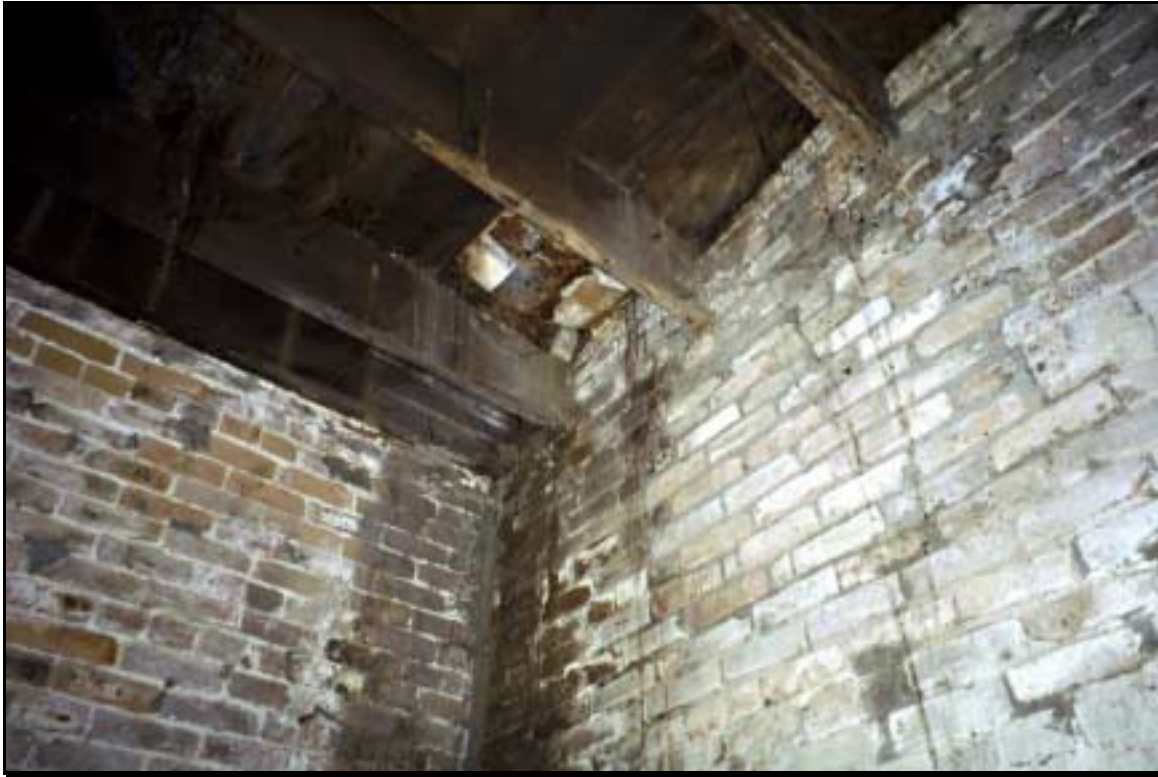
Figure 20. Extensive wood decay and deterioration at the ceiling in the gambling room, corresponding to a blocked roof drain directly above, has resulted in water infiltration and damage to interior materials.

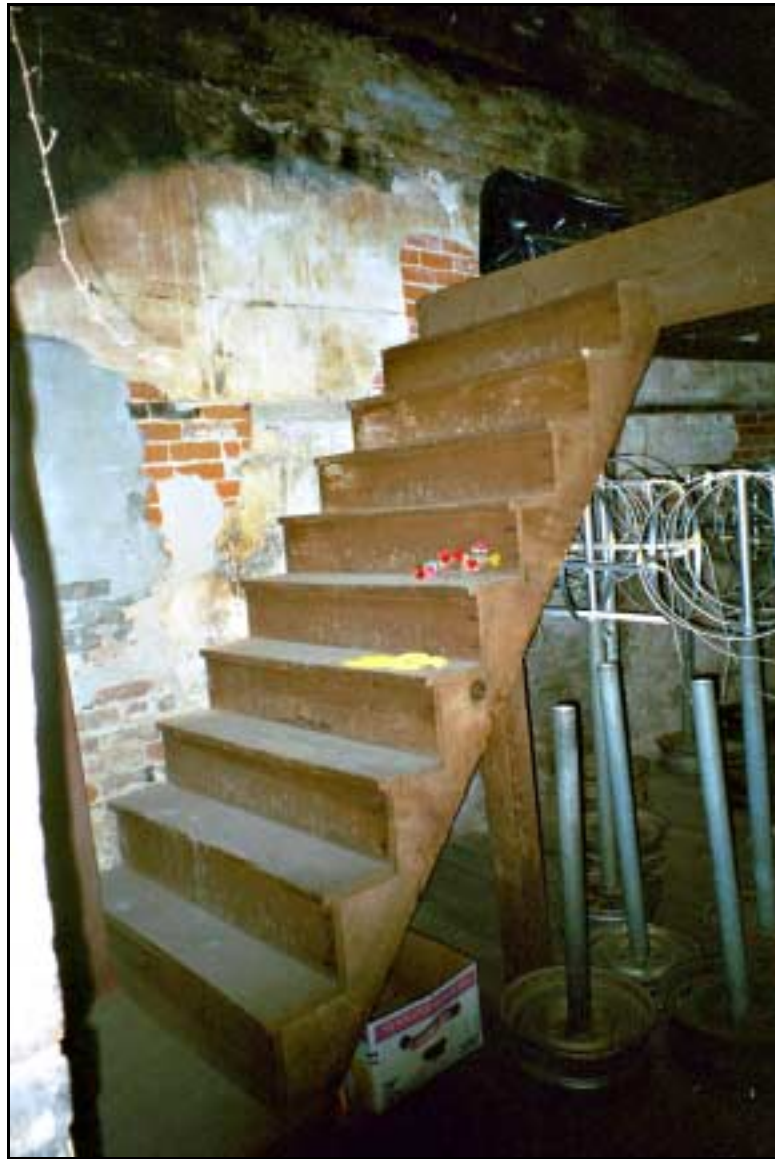
Figure 24. The interior stairs found in the Bok Kai Temple are wood. This stair, in storage room B, leads to a wood platform. The stair does not have a handrail or baluster.
