Appendix B: Photographs of Existing Conditions

The following photographs illustrate typical exterior and interior conditions at the Bok Kai Temple. These photographs were taken by Architectural Resources Group over several site visits during Spring 2002.

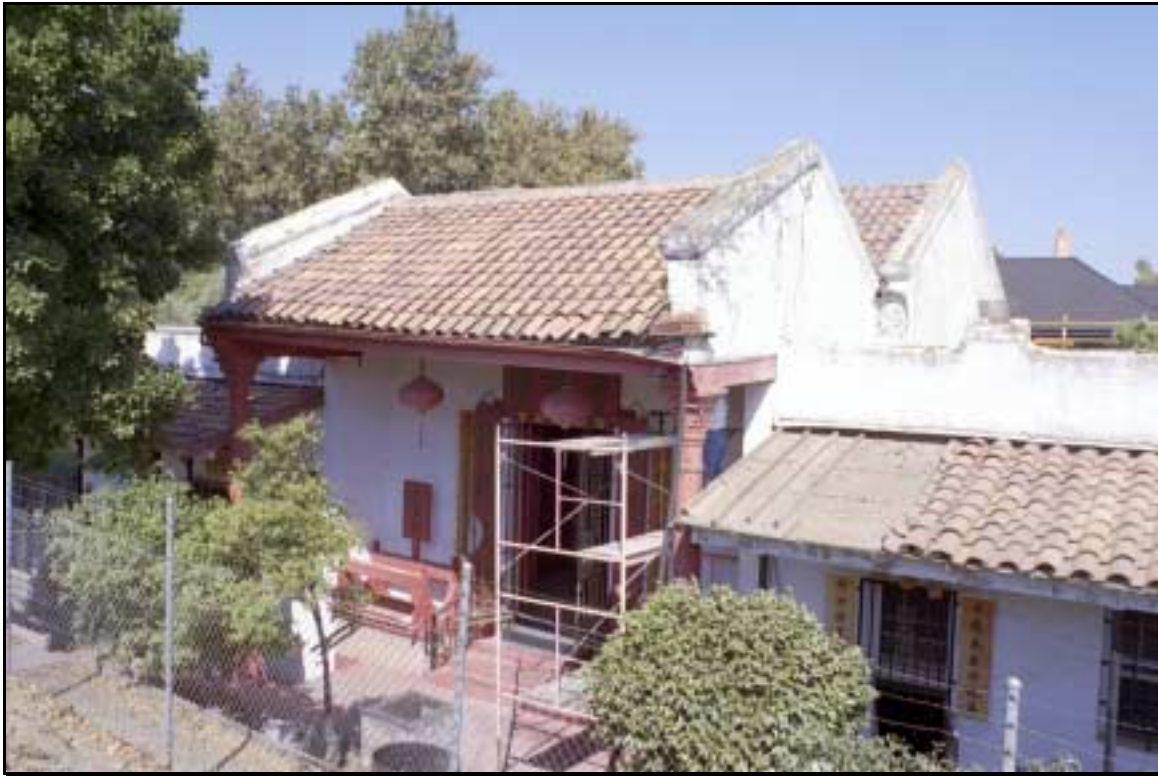
Figure 1. South elevation of the Bok Kai Temple showing the double gable roof over the altar hall, porch over the main entrance into the Temple, and visor roofs over the side halls.

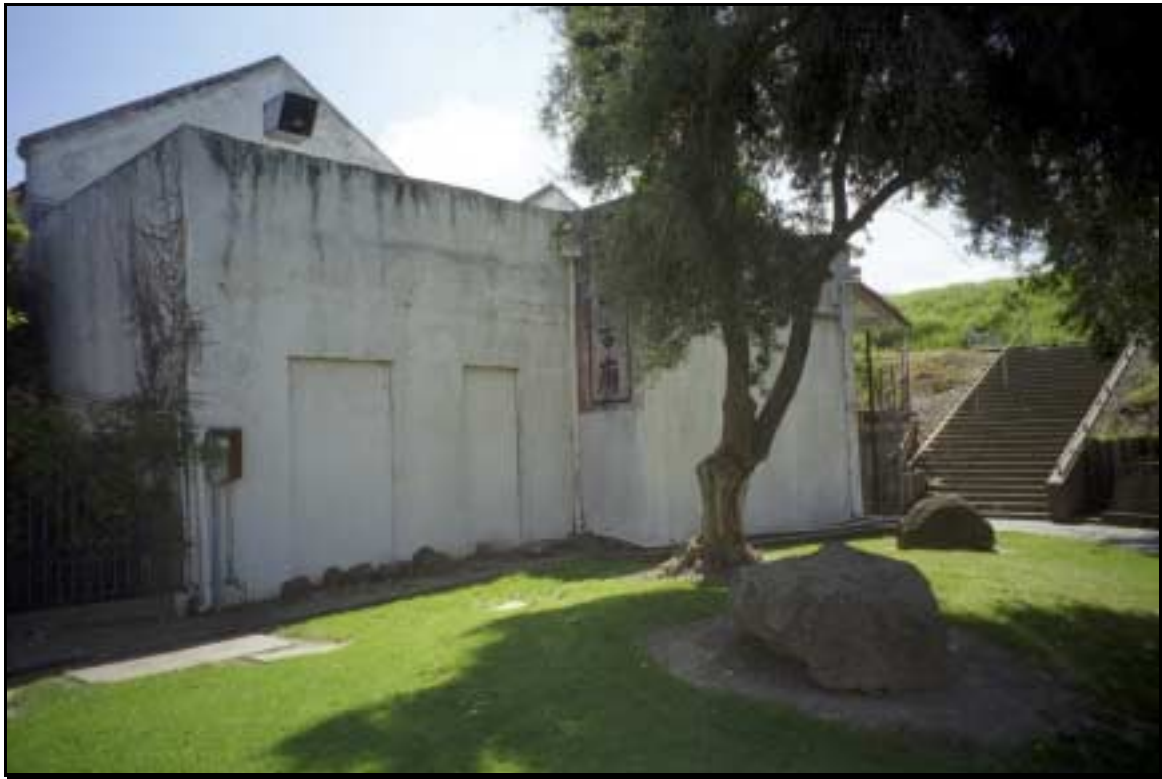
Figure 2. West elevation of the Bok Kai Temple, with park area to the west of the temple and levee embankment to the south.

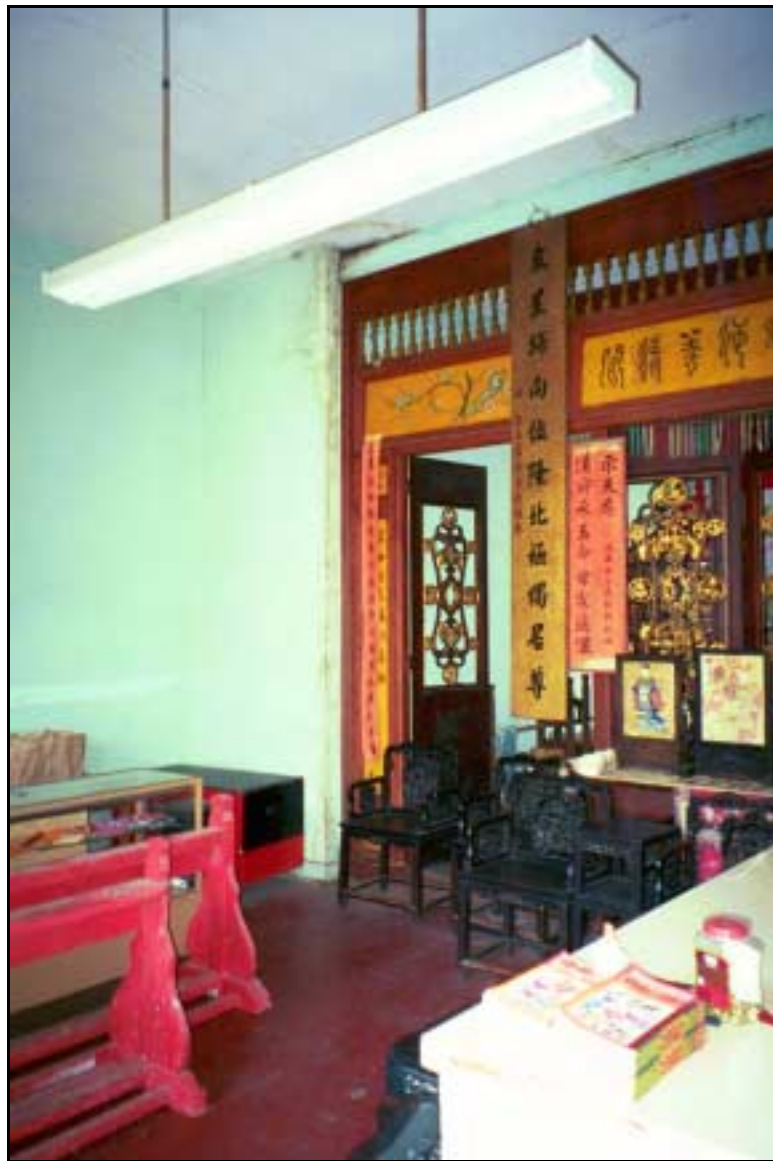
Figure 3. Interior of the council chamber, with the wood partition screen dividing the space into two rooms.

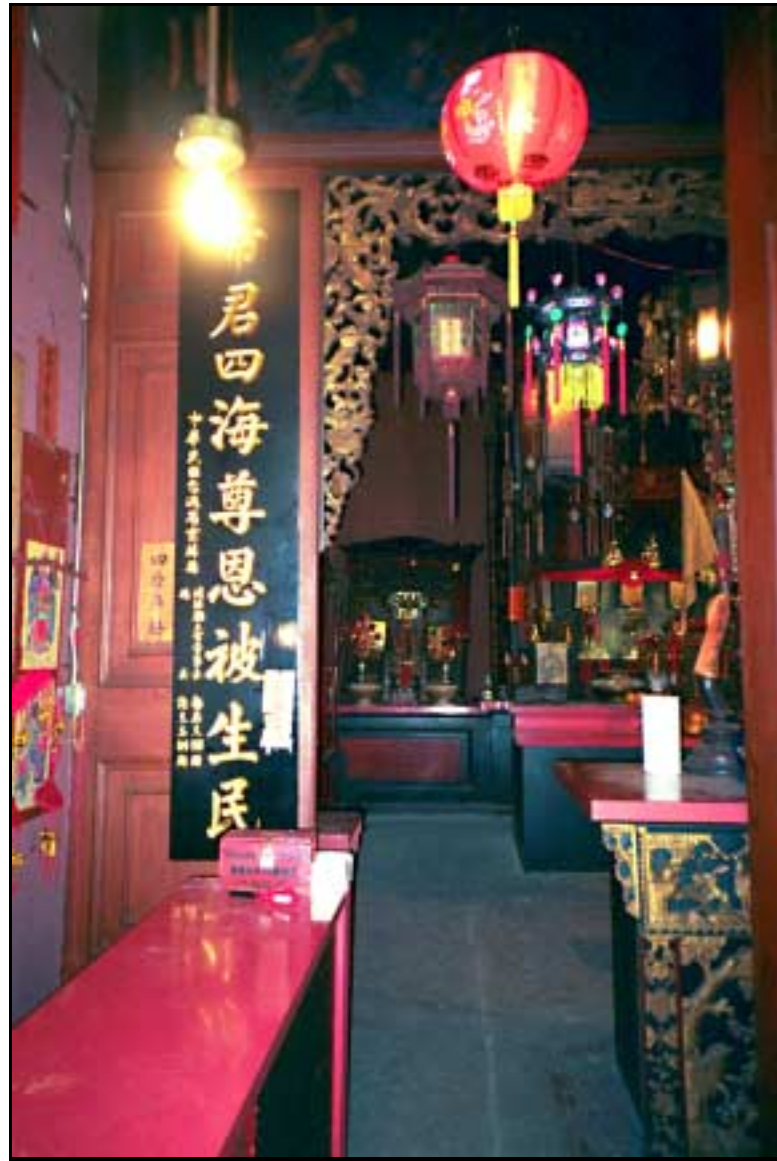
Figure 4. View of the altar hall looking toward the north wall.

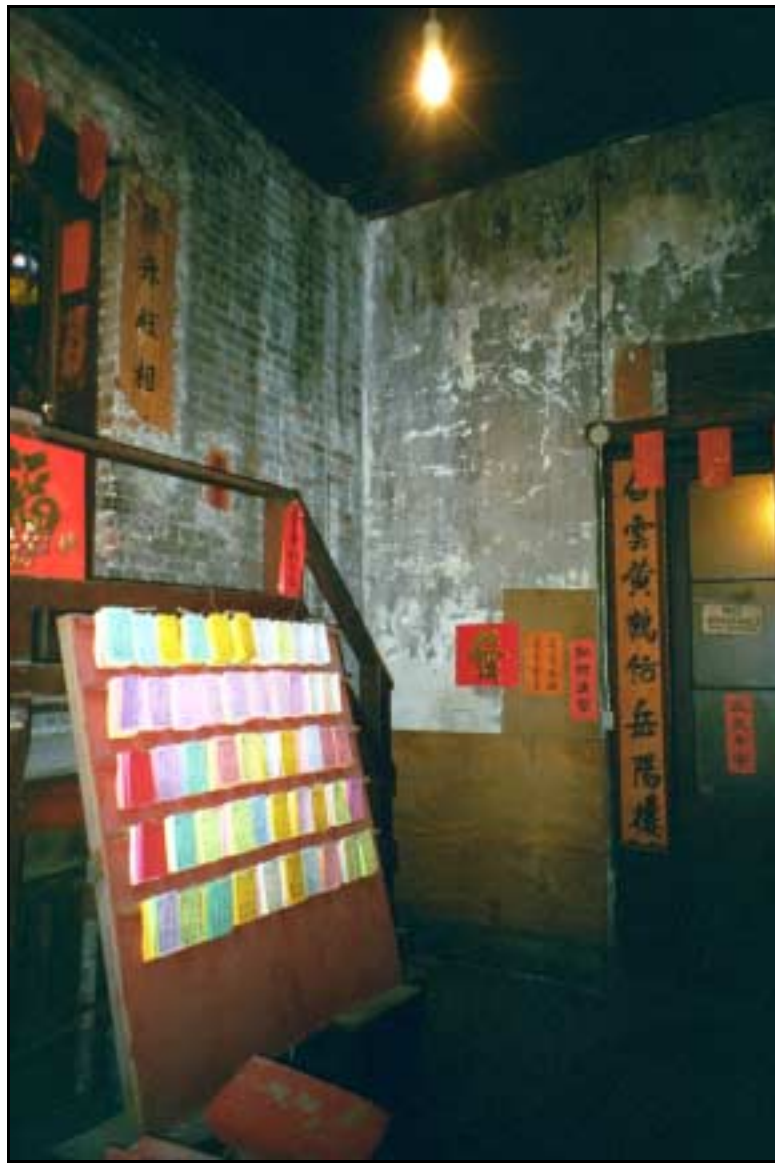
Figure 5. Interior of the fortune reader's chamber looking toward the northwest corner of the room. The stairs along the west wall lead into the altar hall, and the doorway on the north wall opens into a storage room. Resting against the stair and landing on the west wall is the board holding the paper fortunes interpreted by a fortune reader.

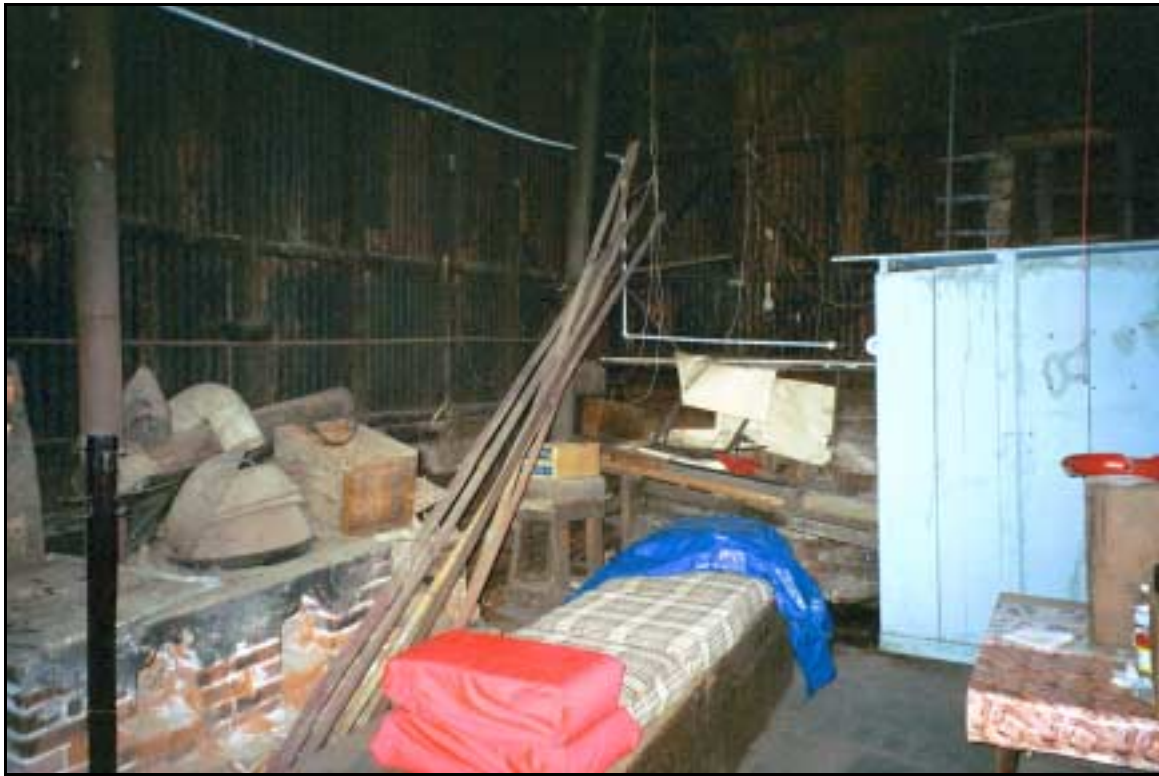
Figure 6. The temple kitchen, looking toward the northeast corner of the building. A brick stove is visible at the bottom corner of the photograph. The blue partition walls are for a toilet room.

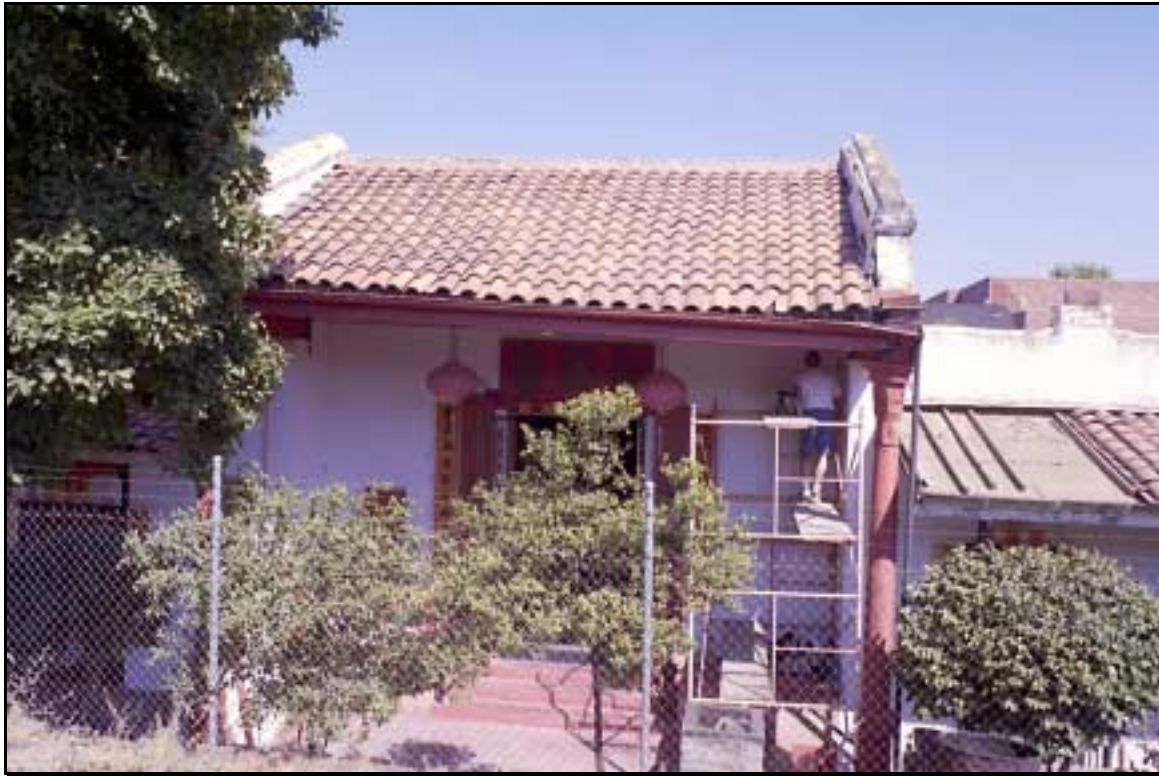
Figure 11. The porch over the main entrance into the Bok Kai Temple consists of brick wing walls supported by wood beams and columns. The porch protects the exterior mural paintings on the south wall of the temple and the wing walls.

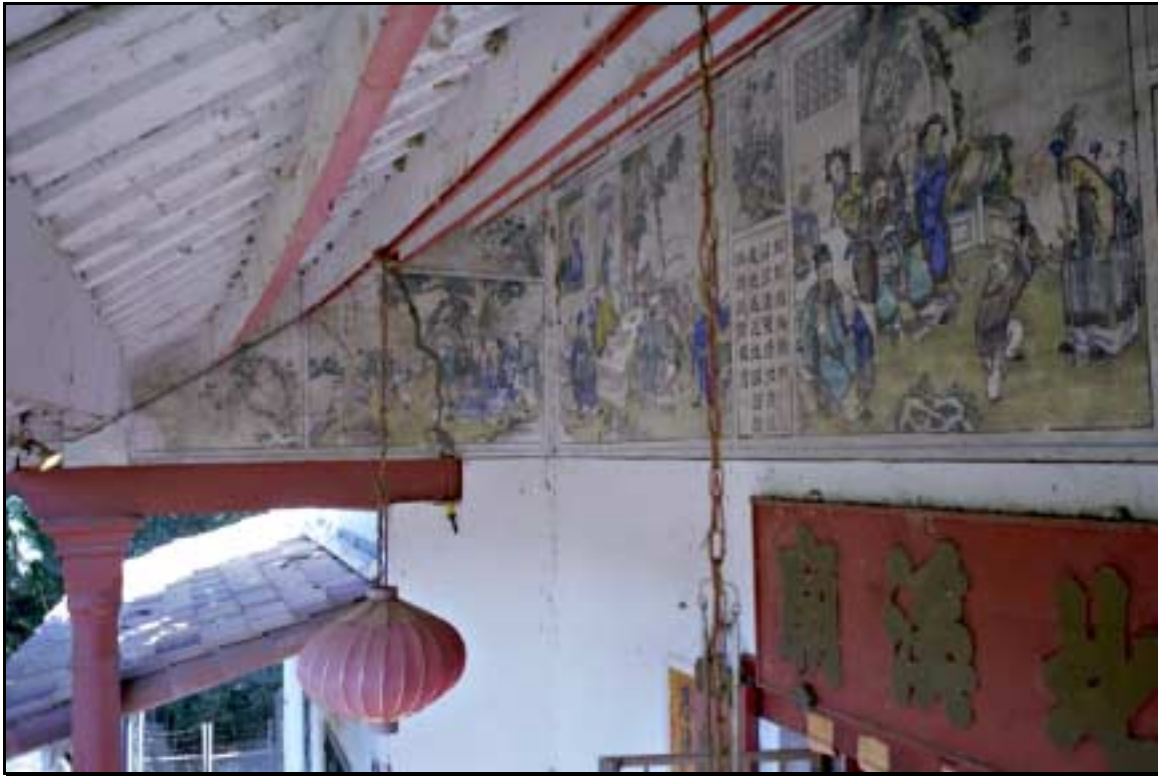
Figure 15. The mural painting under the porch roof contains figurative, decorative, and calligraphic scenes. The mural paintings date to the original construction of the temple, but have been retouched and repaired over the years.

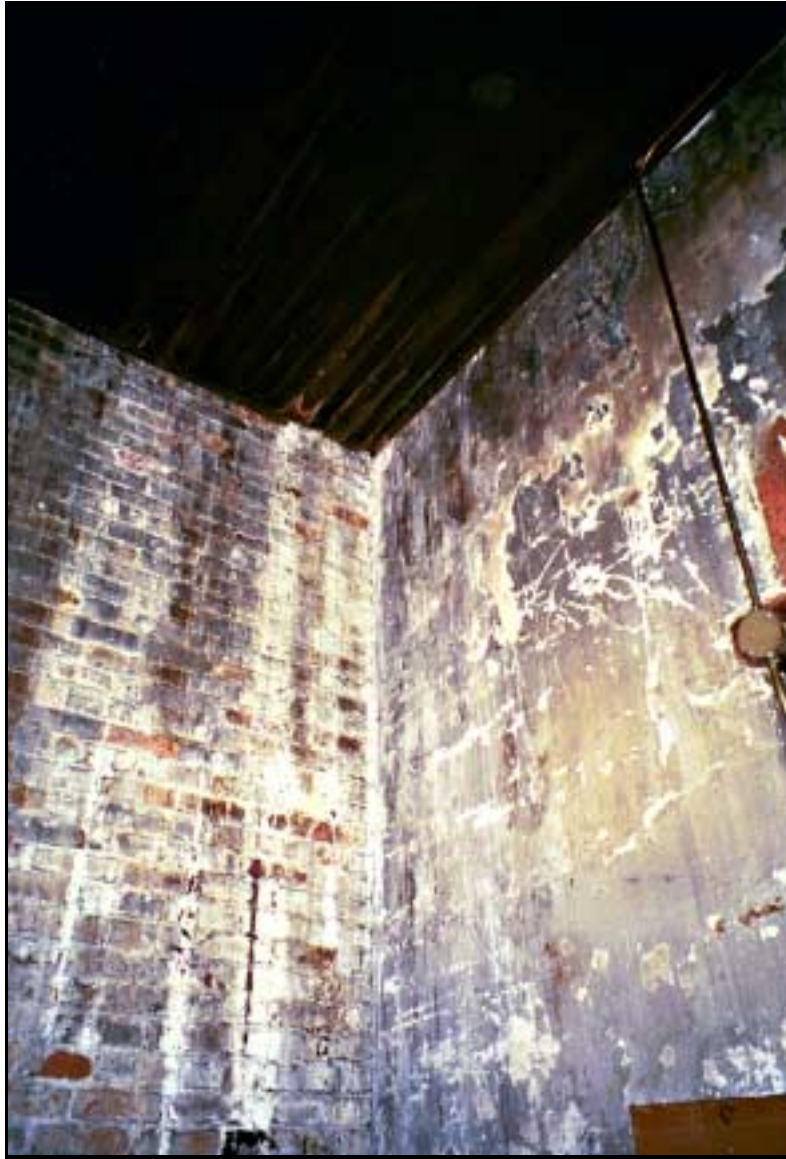
Figure 18. The interior walls of the western portion of the caretaker's wing are brick masonry. Some of these walls are covered with plaster and other walls have exposed brick.

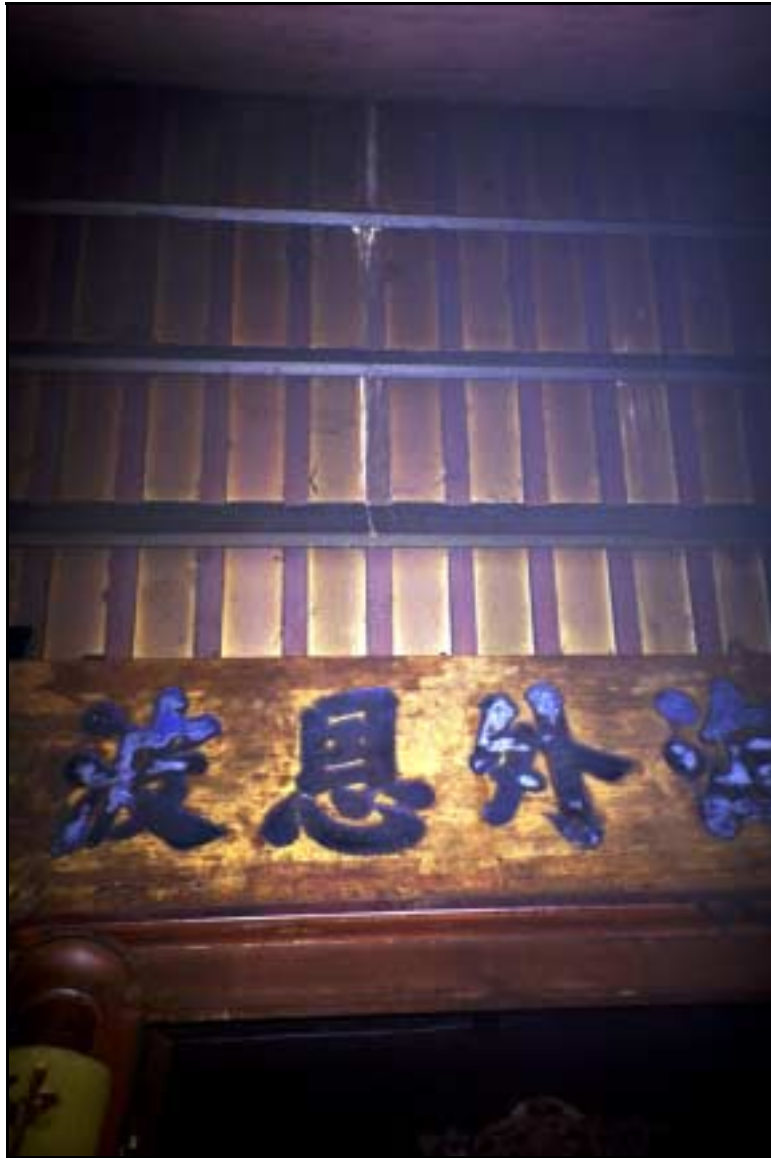
Figure 19. The ceiling at the gable portions of the altar hall has wood sheathing, painted ochre, with red battens over the seams between the board sheathing. The ceiling joists are painted green.

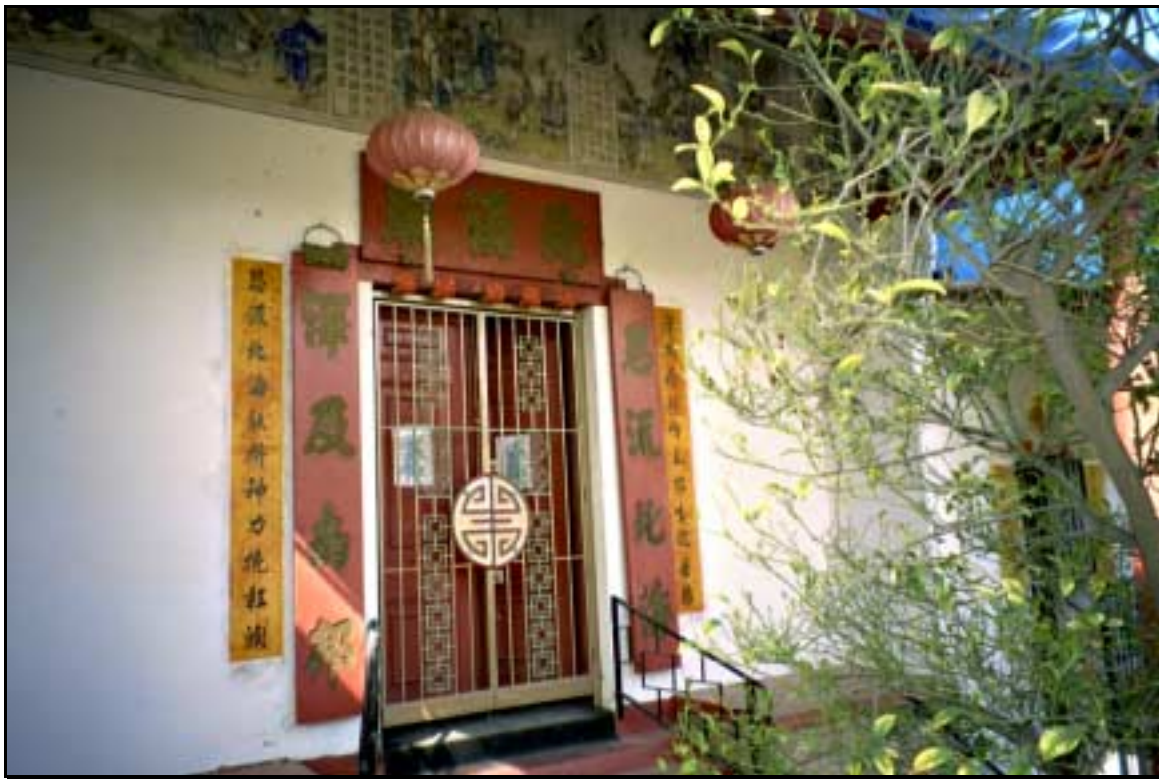
Figure 21. The exterior door into the altar hall, similar to all three exterior doors of the building, has red-painted, wood panel doors with steel security grilles. Wood plaques with carved inscriptions surround the door openings.

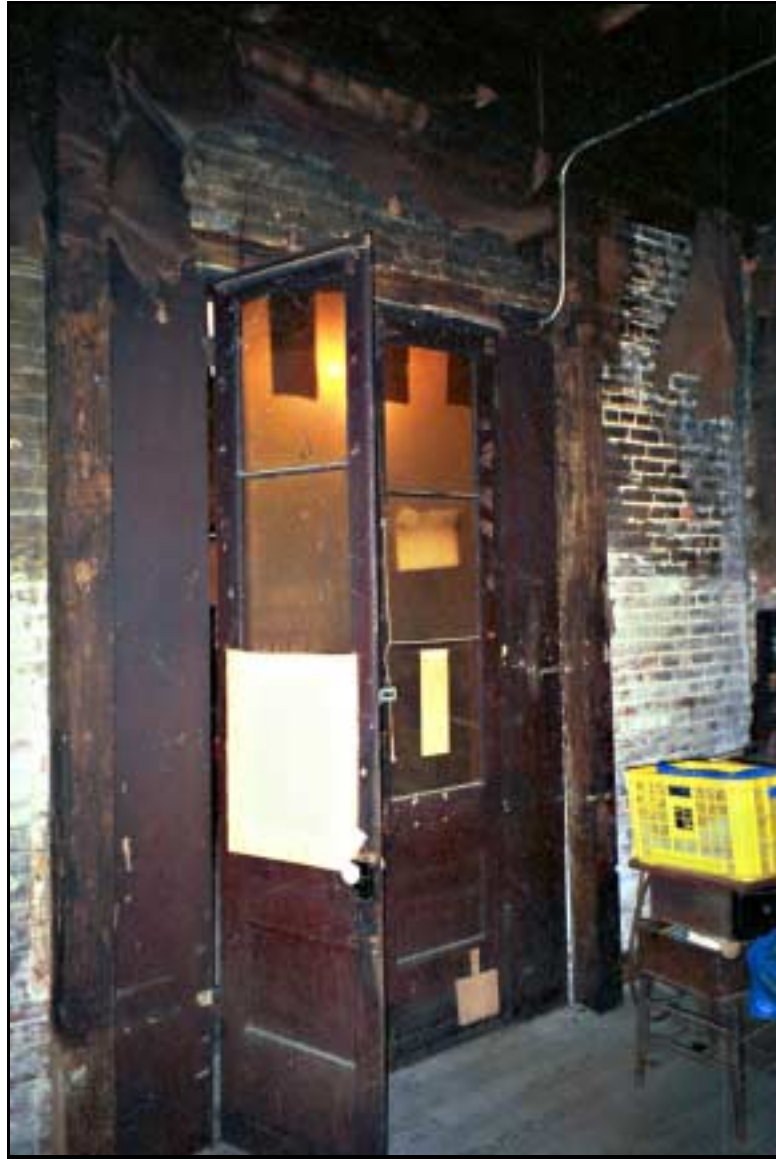
Figure 22. The interior doors in the Bok Kai Temple are wood panel doors. Many of the interior doors are divided with glass panes.

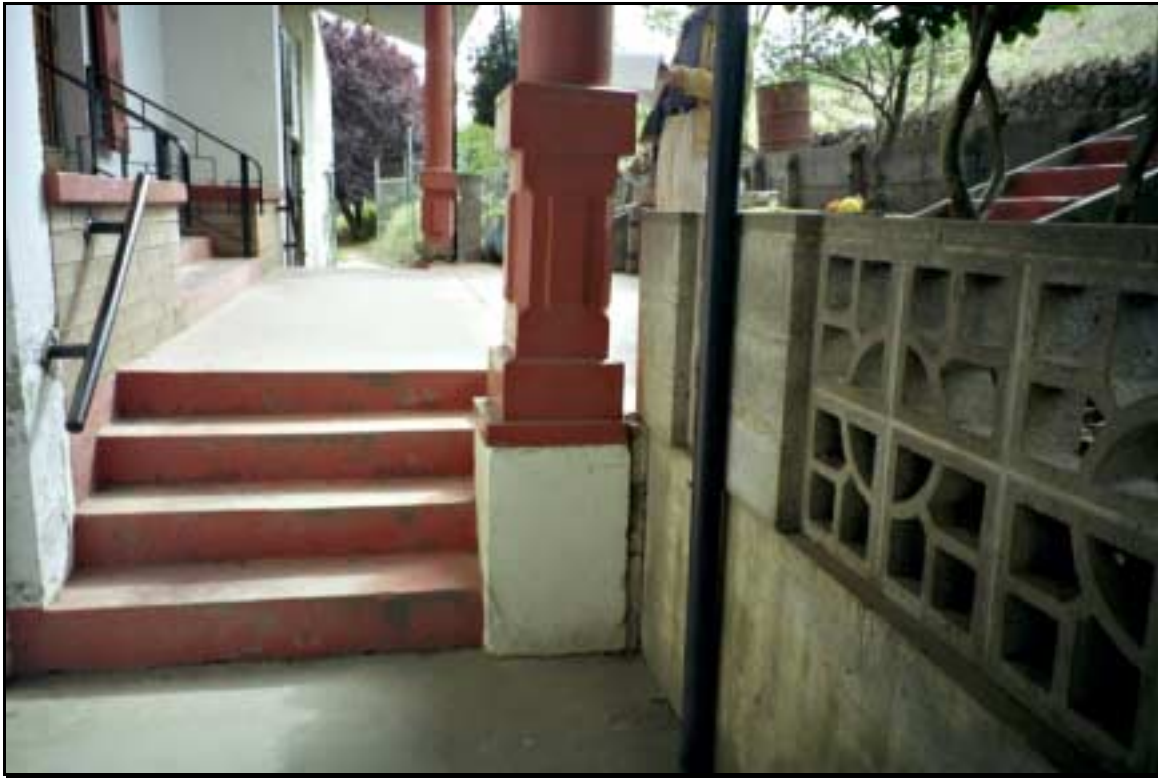
Figure 23. The exterior stairs leading to the main entrance of the temple are concrete steps installed during the 1960-64 renovation project.

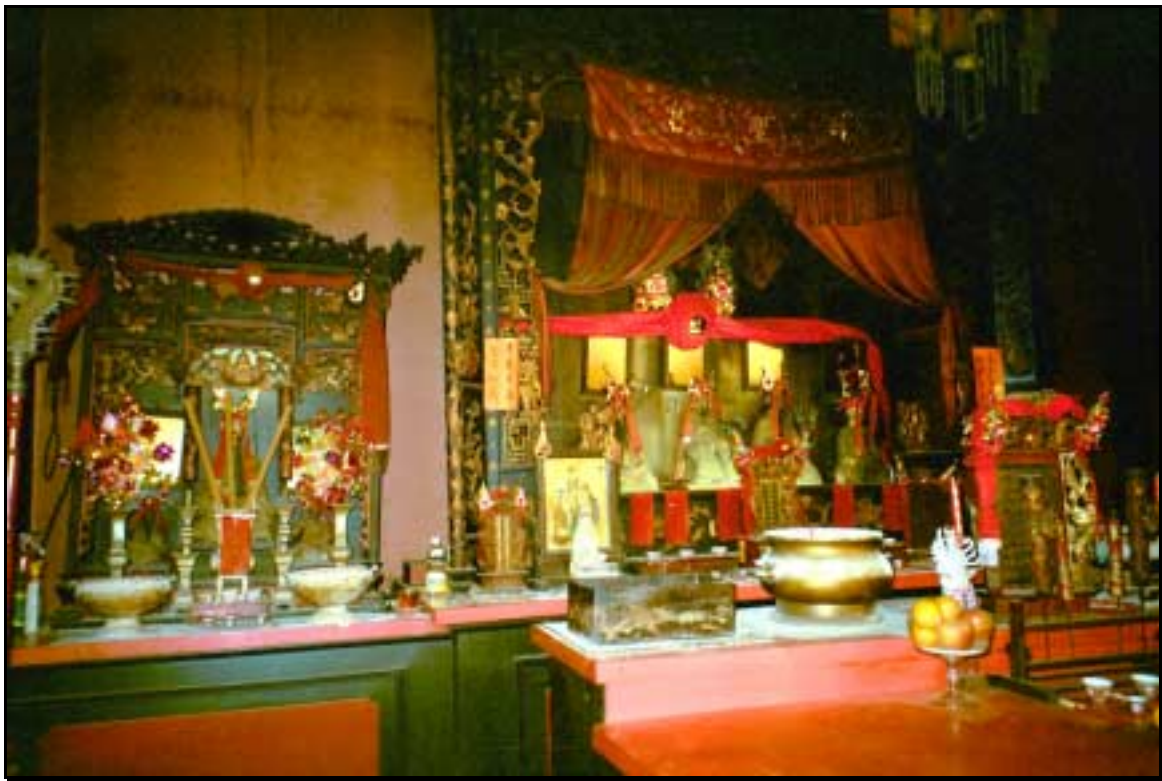
Figure 25. Among the built-in features of the Temple are the altar tables at the north end of the altar hall. These altar tables contain idols of Bok Kai and the other deities associated with the temple.

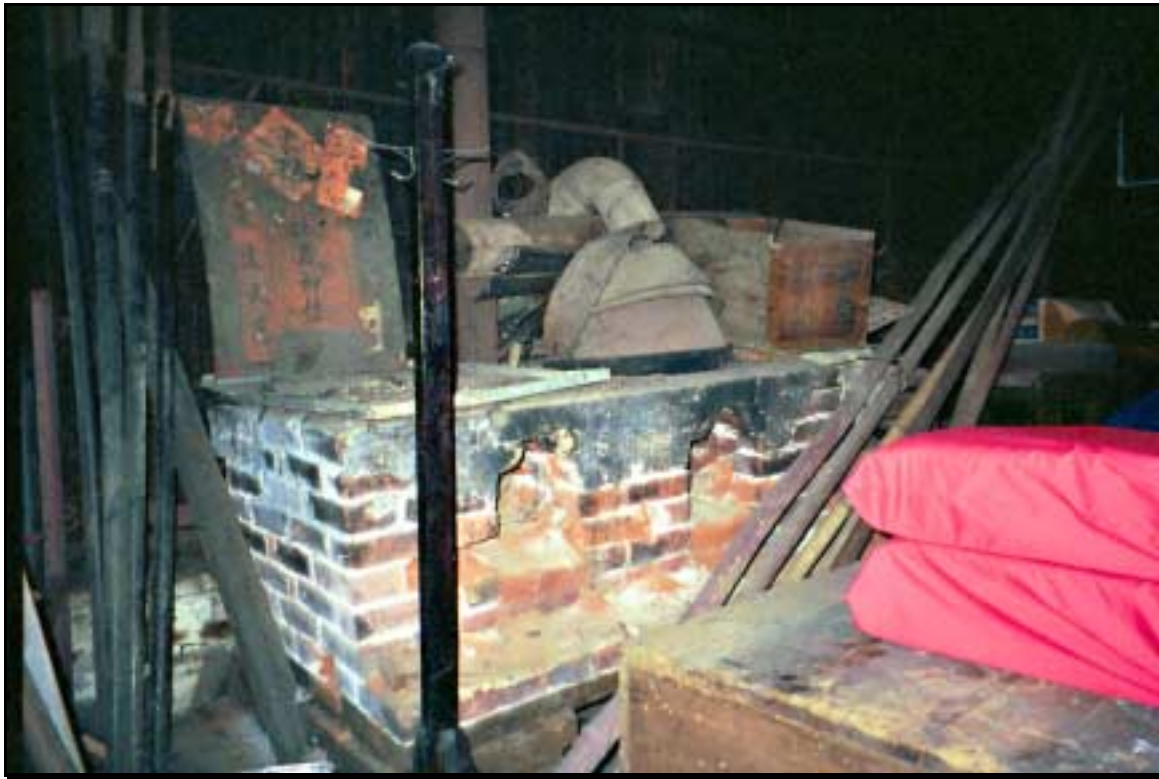
Figure 26. In the Temple kitchen, the built-in features of the building include a brick stove, pictured here, and a brick oven.

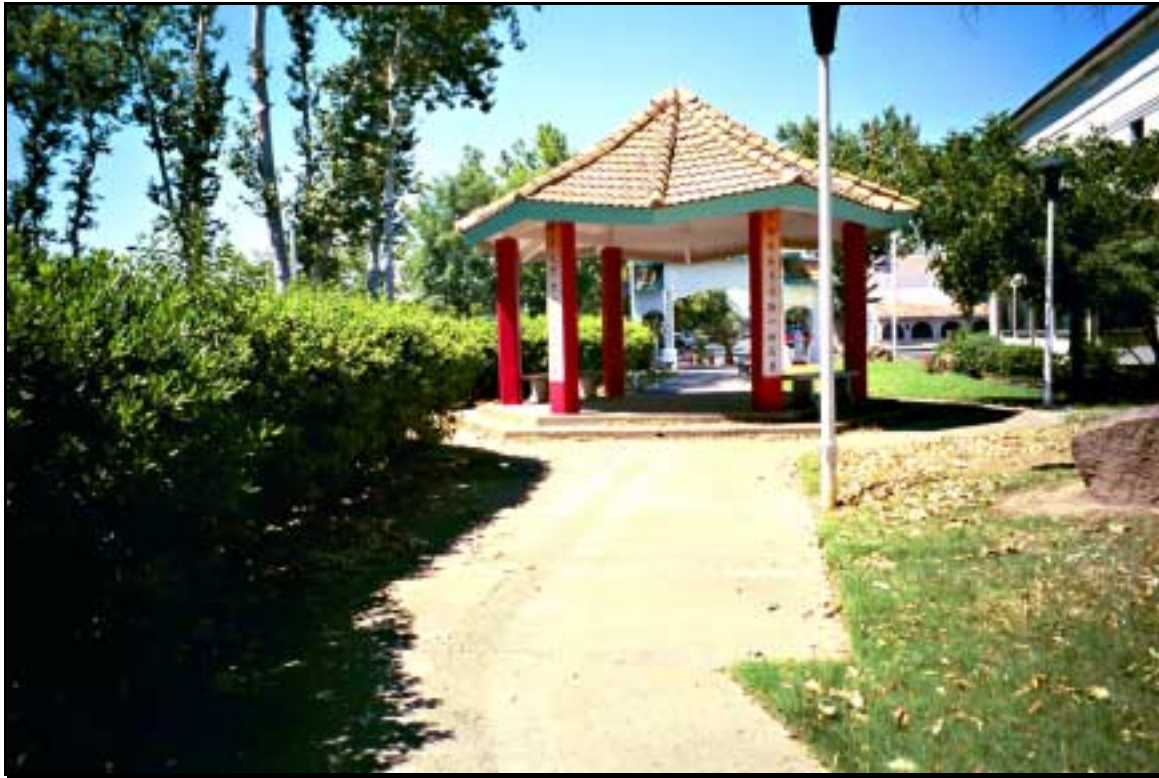
Figure 27. Among the site features associated with the Bok Kai Temple are the archway facing downtown Marysville and gazebo along the pathway to the entrance of the temple.

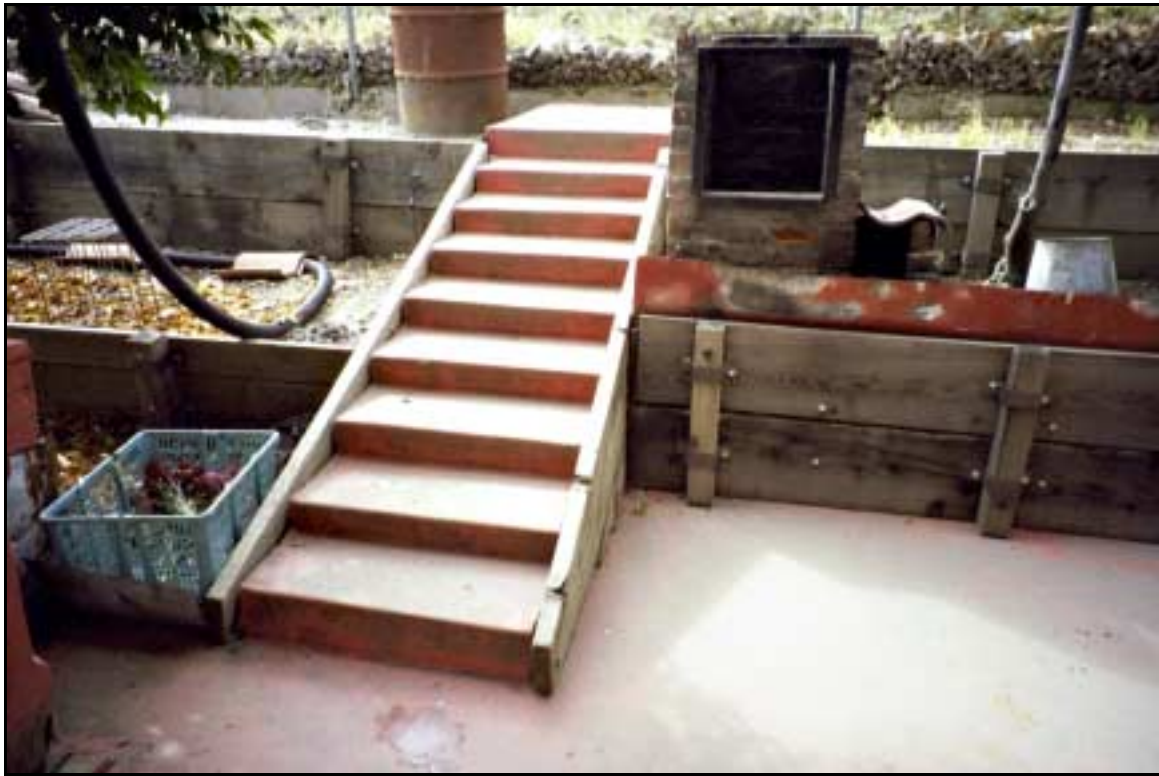
Figure 28. To the south of the temple are concrete steps and planting areas. A brick-burning oven is set in one of the planting areas.
